## REINFORCED CONCRETE CONTAINER FOR II & V MILITARY SUPPLY CLASS STORAGE

### TECHNICAL DATA SHEET

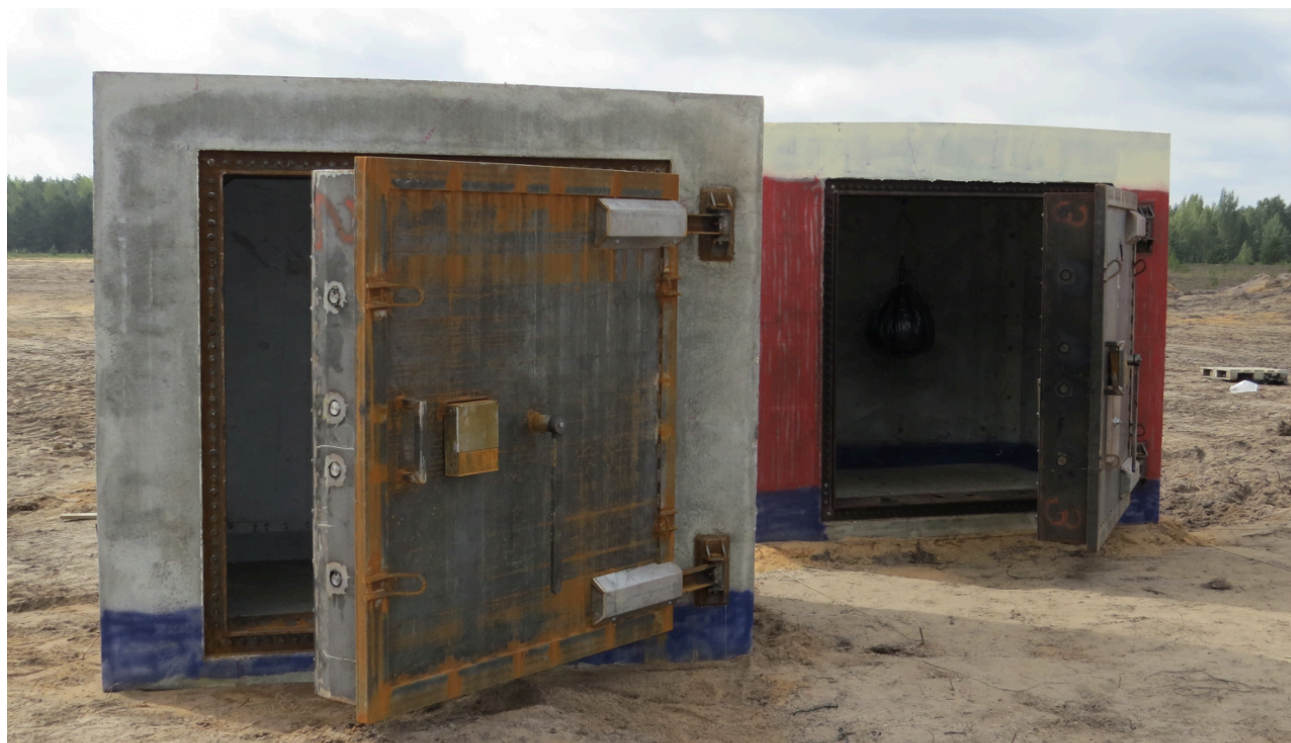
**Figure 9.** Test #2. 50(kg) M46. Containers staggered, 1(m) apart.

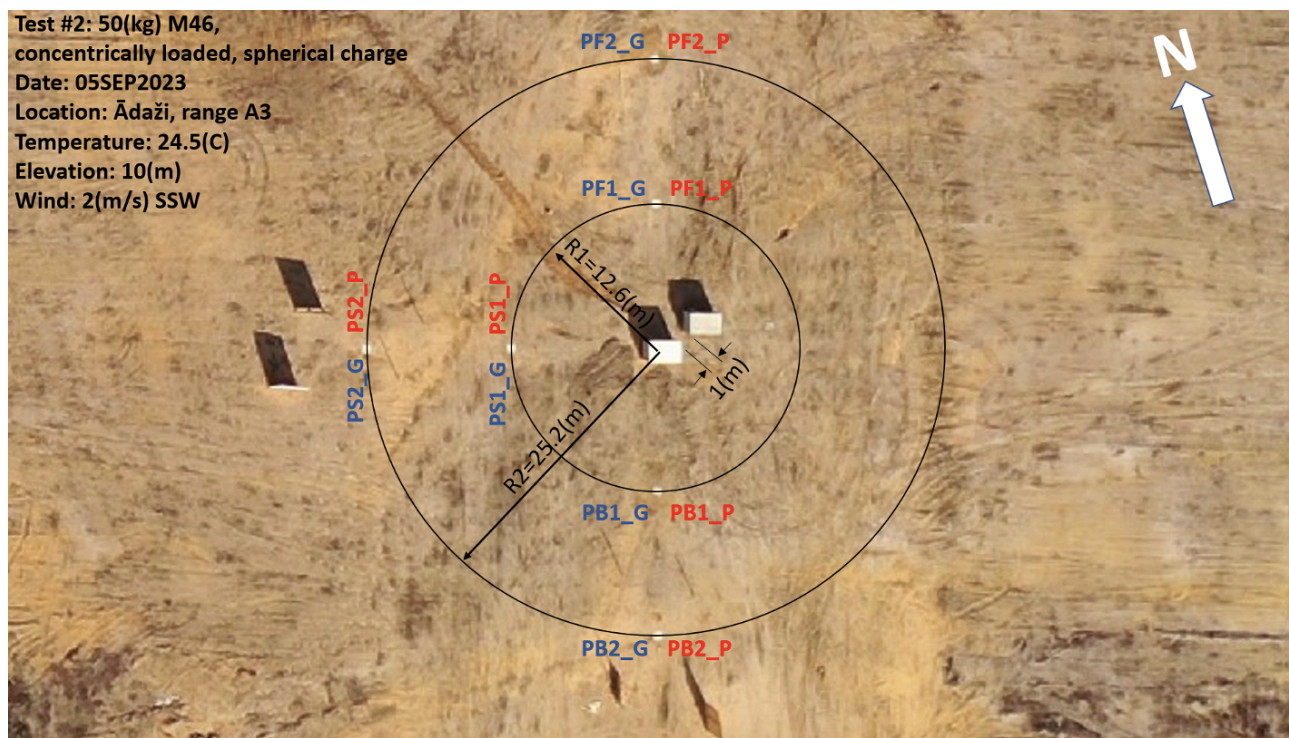
**Figure 10.** Test #2 setup; drone view. Container No.2 loaded with 50(kg)\_M46, exposed site at 1(m).

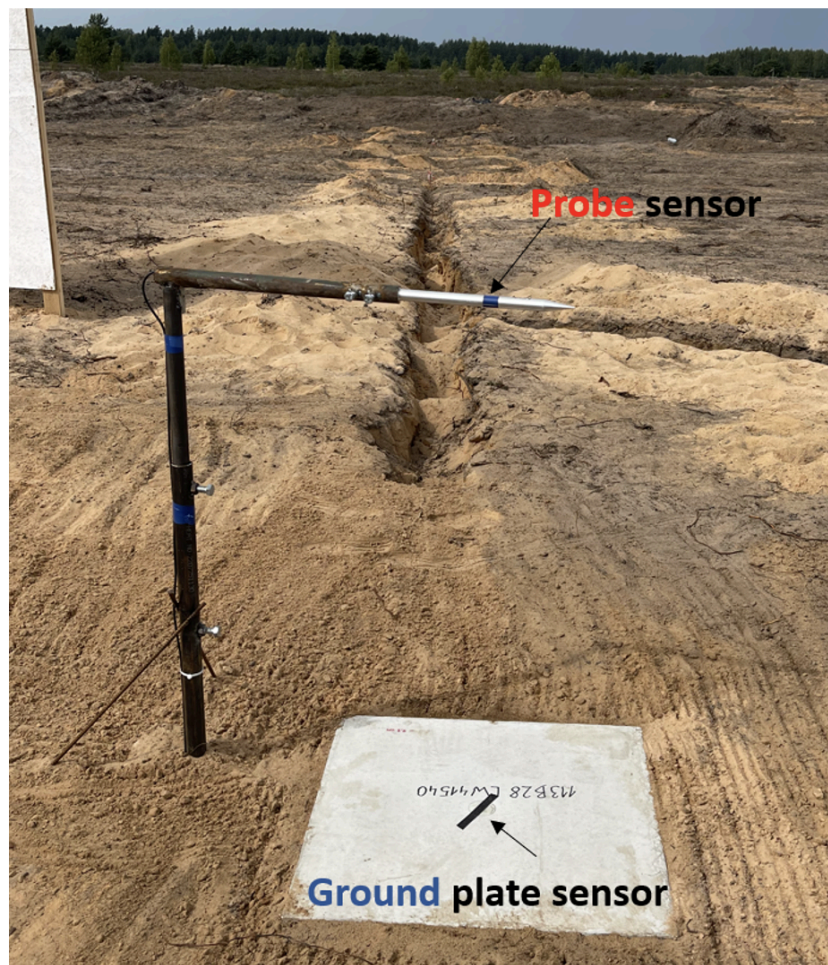
**Figure 13.** Pressure sensing station. Sensors covered with pvc electrical tape to delay heat transfer.

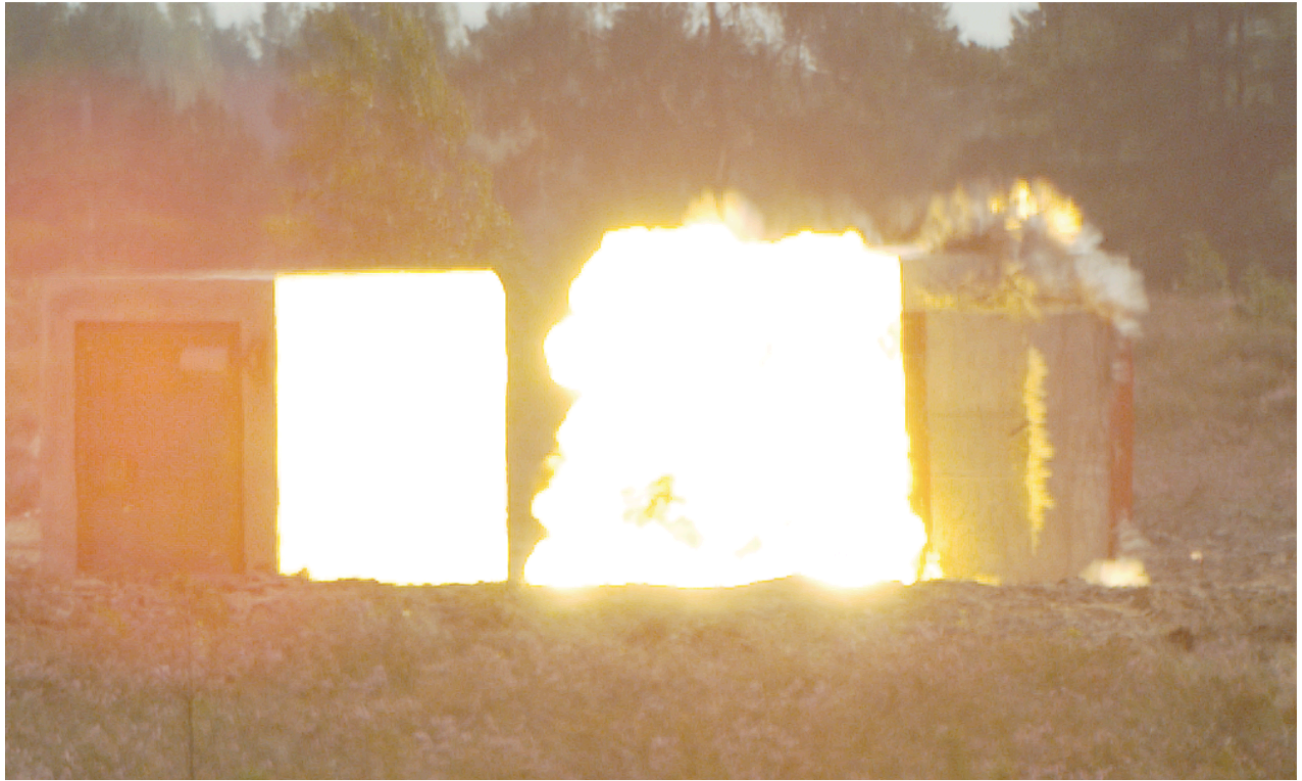
**Figure 19.** Test #2. Venting through the shear lines and side wall splitting vertically

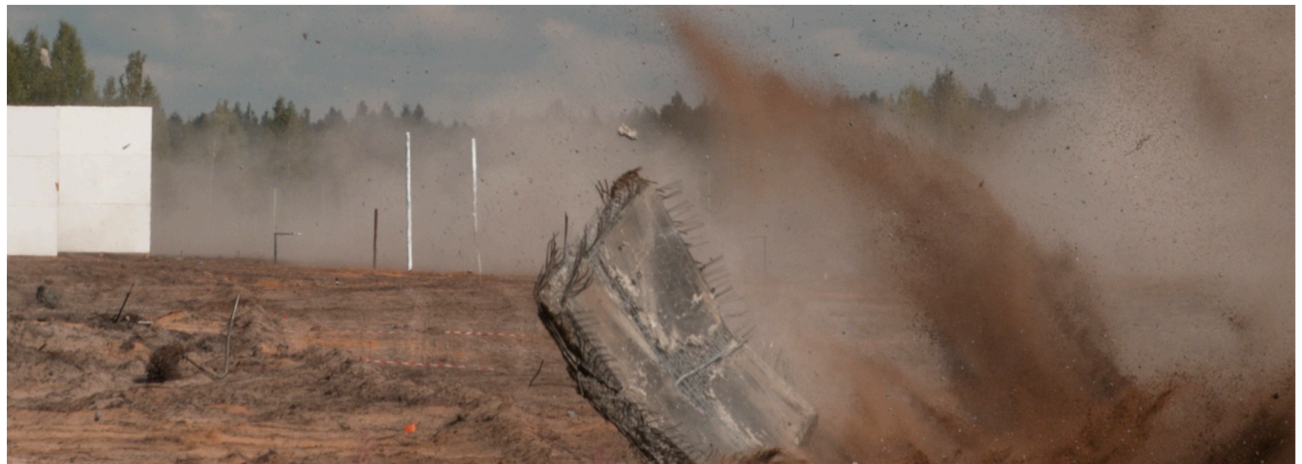
**Figure 20.** Test #1. Back wall rolling through the field of view of a high-speed camera facing 0° bearing to observe the left side wall fragments. Inside face towards the camera. Compression failure visible.

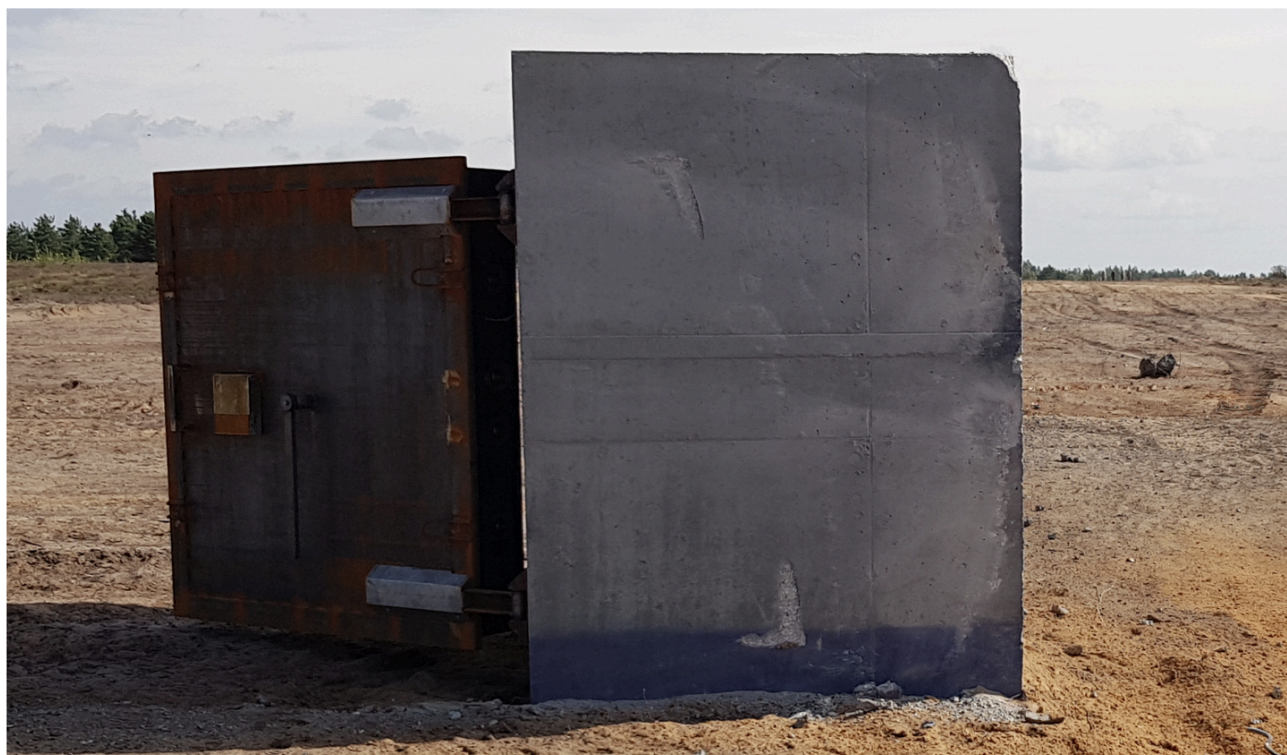
***Figure 21. Test #2. Impact marks on the ES from the corner fragment of PES.***

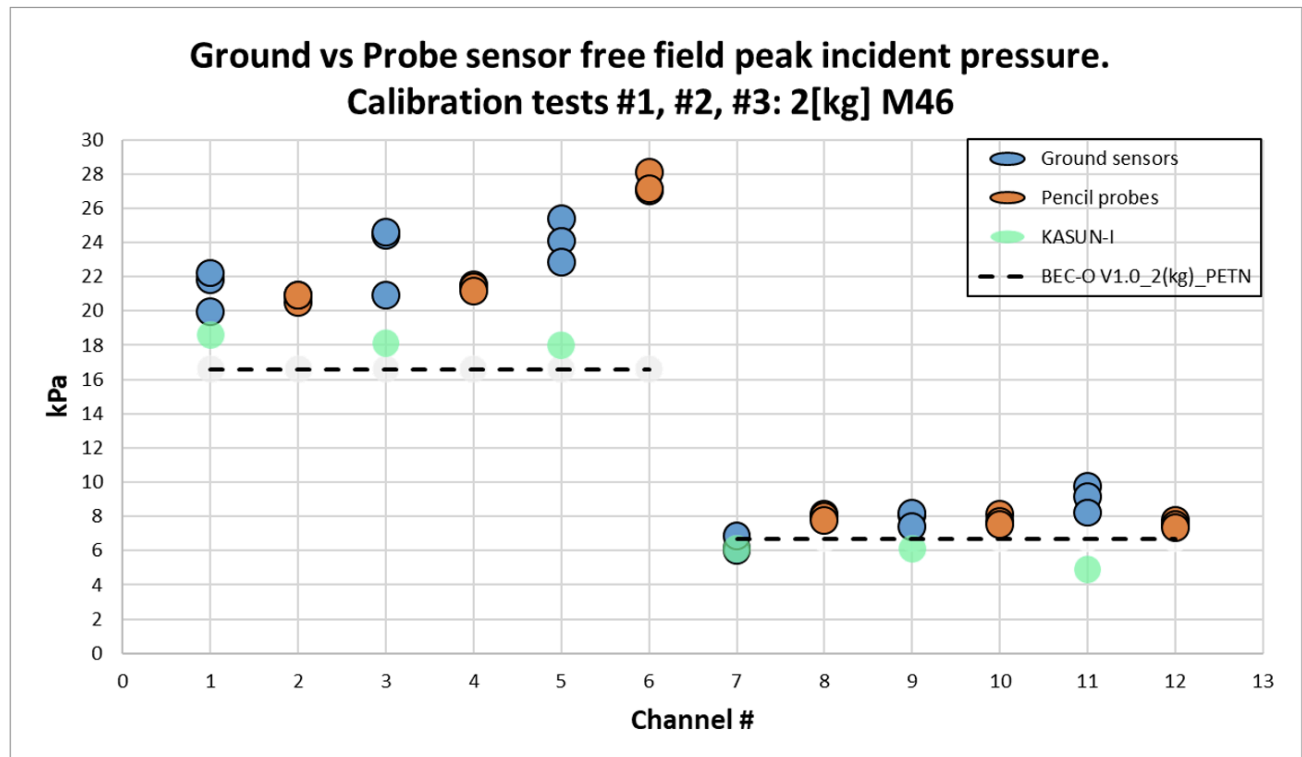
**Figure 22:** Calibration tests. Ground vs probe sensor free field incident pressure. KASUN-I and BEC-O values provided for reference.

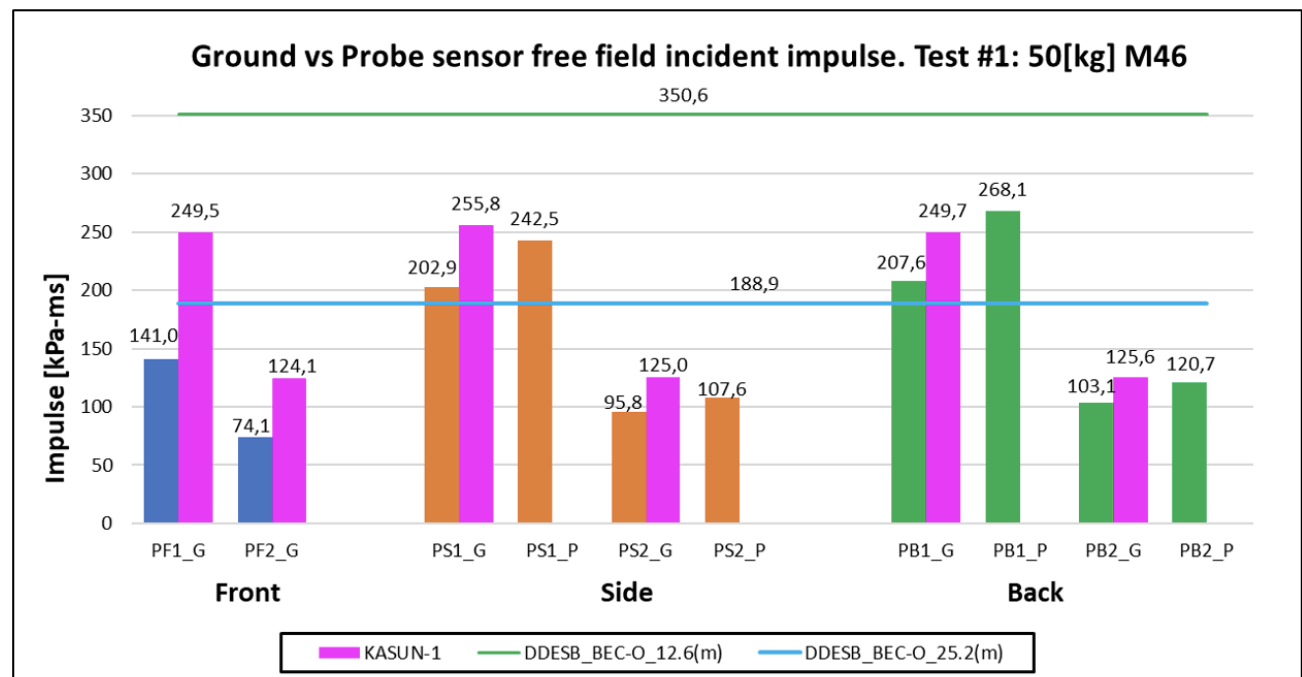
**Figure 25.** Test #1. Free field total impulse (positive phase). Color-coded principal directions. KASUN-I and BEC-O\_50(kg) PETN values provided for reference.

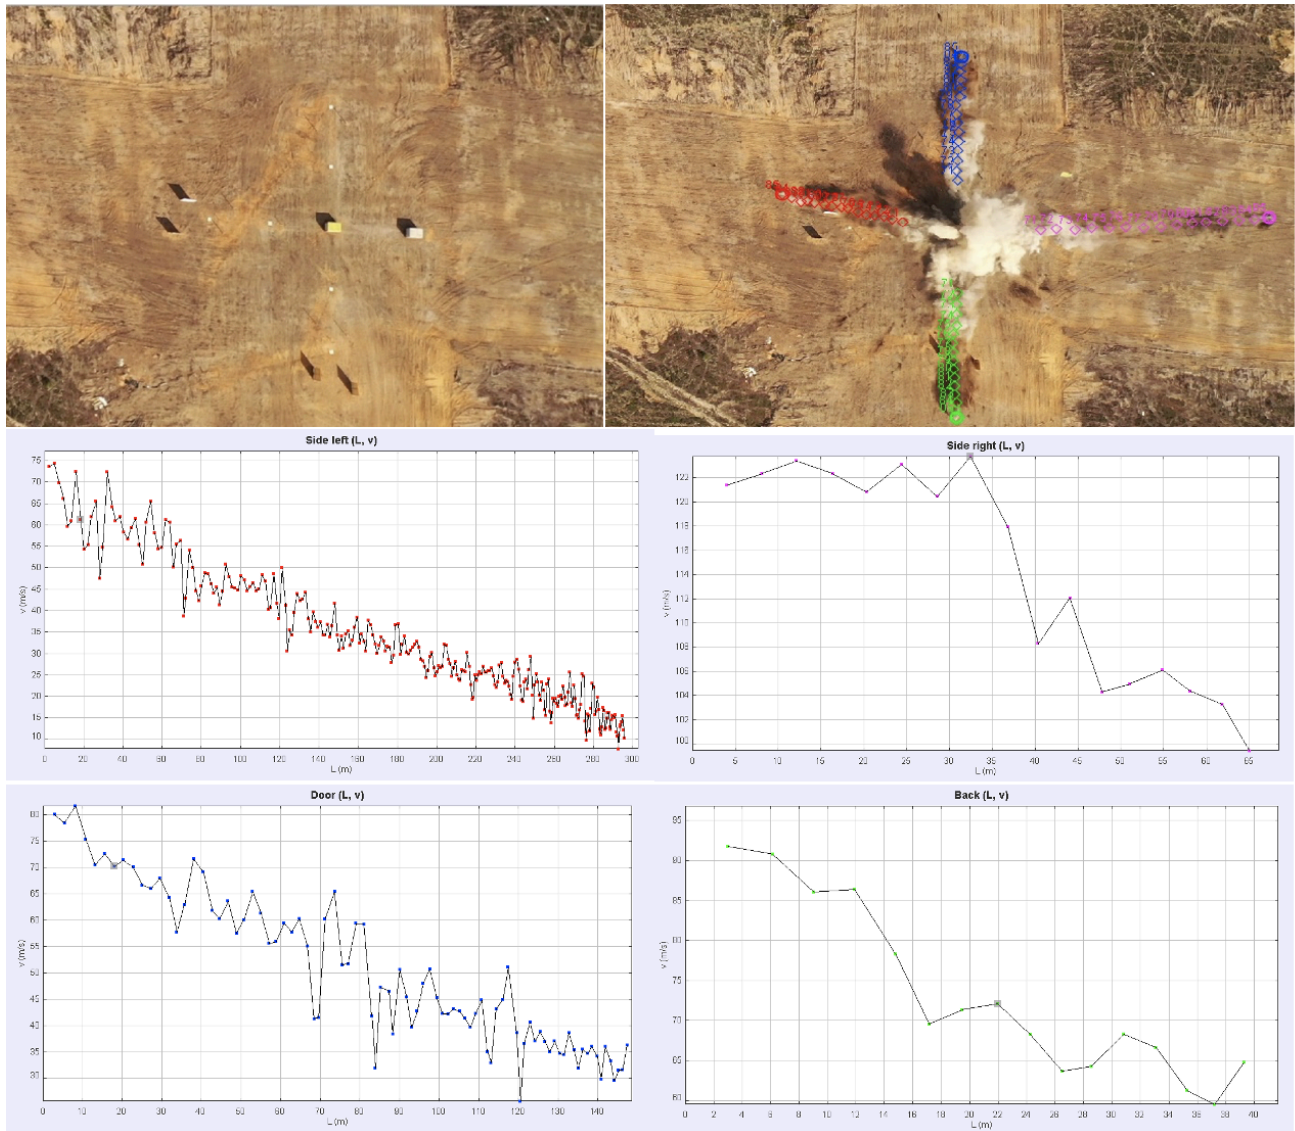
**Figure 28. Test #1. Distance traveled (m) vs velocity (m/s) of all four large fragments.**
